Royal Borough of Kingston upon Thames
Character Appraisal and
Management Strategy Programme

Park Road Conservation Area

July 2008

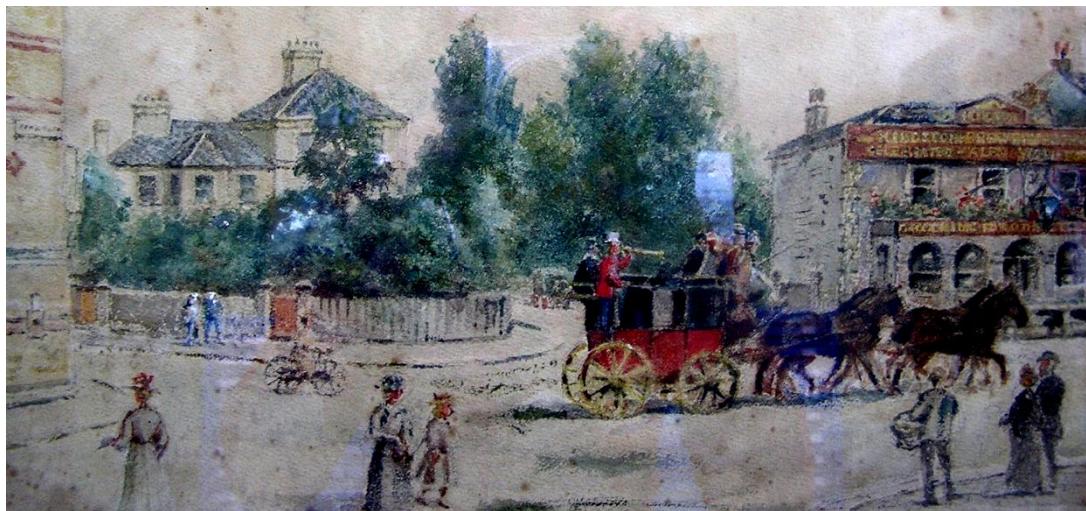
Figure 1: View of the Kingston Hill/London Road/Manorgate Road junction - late 19th century watercolour in Kingston Museum's Local Studies Collection

The last major development was Bank Broadway, 4-16 Kingston Hill, in 1905, replacing a group of 1860s villas on the south side of Kingston Hill. One of these can be seen on the left of the painting in *Figure 1*.

3.43 The present Kingston Gate public house, built in 1966, replaced (on a set-back building line) an older public house, the Black Horse, shown on the first edition OS map (*Figure 4*) and contemporary pictures, fronting directly onto London Road until 1966 (see *Figure 1, page 2 and Figure 8, page 24*). The new siting resulted in a parking forecourt, which has weakened the enclosure of the junction. The present public house is bland mock-Georgian, which, in combination with its car-park, has a negative impact.

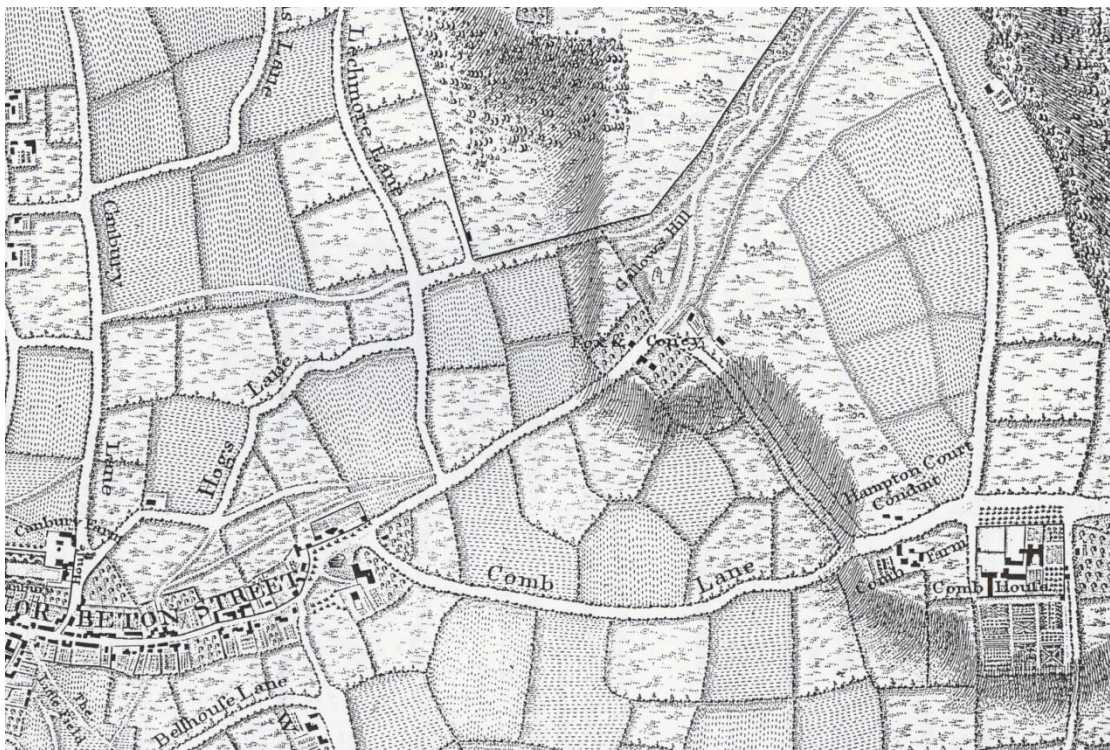
Figure 2: John Rocque's 1745 map

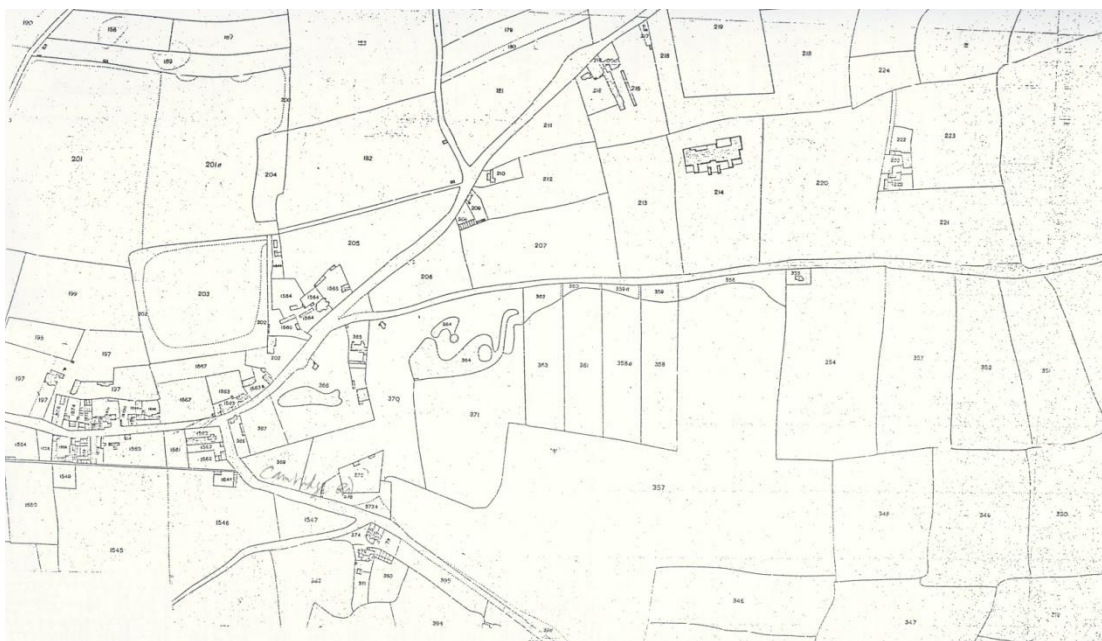
Figure 3: Tithe map, 1840

- 3.3 There are various reports from 1530 through to 1863 of Roman finds in the Coombe Park area³. There is evidence from medieval field names to suggest⁴ a pre-Saxon town of about 500AD on a site immediately to the north-east of the conservation area. From the 9th to the 11th century, Kingston was a local administrative centre of a king's estate; granaries ('beretons') stored grain at the perimeter of the estate, giving the likely origin of the names Norbiton and Surbiton, from North Bereton and South Bereton. In the medieval period, the area was farmed on an open field system, and was later enclosed between the mid-15th and mid-17th centuries. The road over Kingston Hill to London is first shown on a map of 1637 when Richmond Park was enclosed. This historic route was originally a Turnpike Road with a toll gate at the bottom of Kingston Hill. John Rocques' map of 1745 (*Figure 2*) shows a few buildings along London Road and at its junction with 'Comb Lane', with open fields beyond. The situation had not changed greatly by the time of the 1840 tithe map (*Figure 3*), and these field boundaries largely determined the pattern of subsequent development.

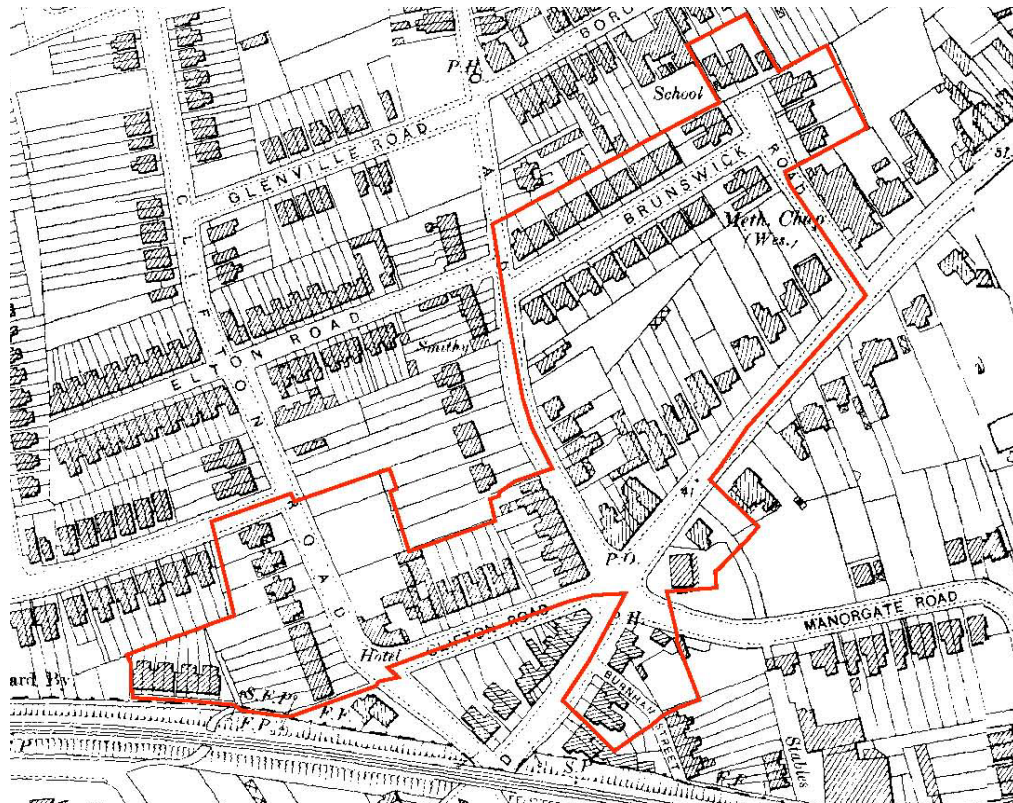
Figure 5: Extract from Ordnance Survey map, 1898

- 3.6 The 1898 map (*Figure 5*) shows this extensive speculative development - the conservation area, like its setting area, is substantially built up with a wide range of sizes of property. The construction of Clifton Road, with Manorgate Road and Station Road which were new links to Norbiton station, created a much larger junction where previously only Park Road joined the London Road/Kingston Hill route. The development in the 1870s of 1-7 Kingston Hill as a post office and shops, and 1-13 Park Road as a parade with flats above, began to establish the area around the junction as a local shopping and commercial area serving the new residential streets. Bank Broadway of 1905 and the addition of 'bungalow' frontages to the earlier group at 196-200 London Road (now demolished) continued this trend, making the junction into an increasingly busy focus of activity.

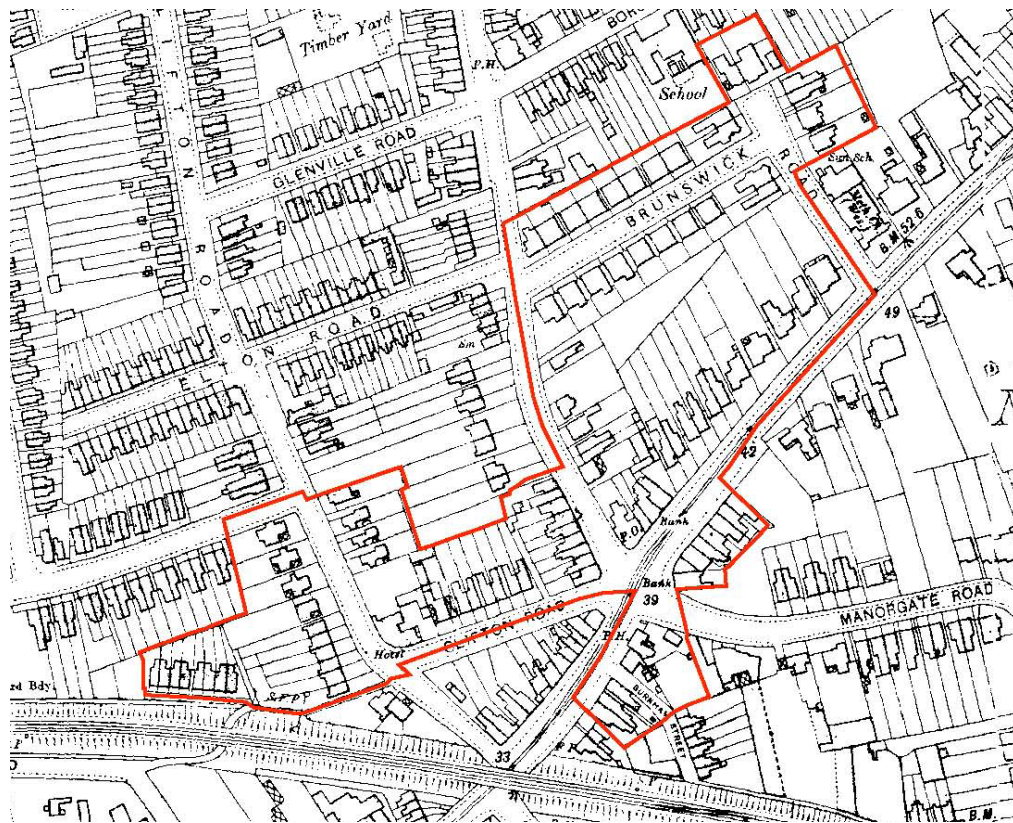
Figure 6: Extract from Ordnance Survey map, 1913

- 3.7 The 1913 OS map (*Figure 6*) shows few sites for development remaining. Most future change was to be on the basis of re-development of existing buildings, except for 10 and 12 Park Road in 1937, and the 'works' (now car repairs) from the 1950s at the rear of the 14 Park Road. Two mid-20th century developments affecting views out of and within the conservation area have been the re-development and re-location of the public house (formerly The Black Horse, now re-named The Kingston Gate) at the junction of Manorgate Road and London Road in 1966, and the development of 189-201 London Road as a petrol filling station, also in 1966; although this is not in the conservation area, it directly adjoins it. Later 20th century developments in the setting of the conservation area include the townhouses on Kingston Hill; The Farthings at the south east end of Brunswick Road, Audric Close (1982) off Park Road; and Aldous Court in Clifton Road. These all have a neutral-to-negative effect on the setting of the conservation area. The group of properties at Nos. 196-200 London Road was demolished in 2006 following the grant of planning consent for re-development of the site.

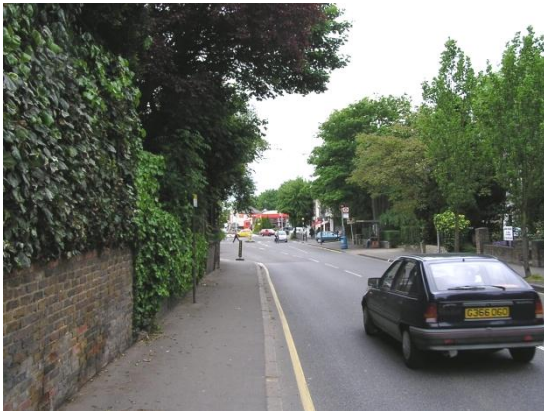
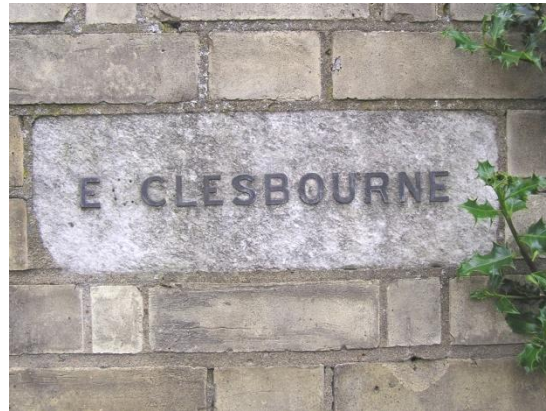
3.19 The 1970s houses on the south side of Kingston Hill are barely visible from the road, but outside the conservation area boundary, parts of the old boundary walls and piers from the Victorian villas they replaced are still there, one with an incised name (*below*). These, and the steep ground behind, contribute to the sense of containment of this part of the hill.

Views contained by greenery and old boundary walls, and a gate pier from a villa demolished 30 years ago

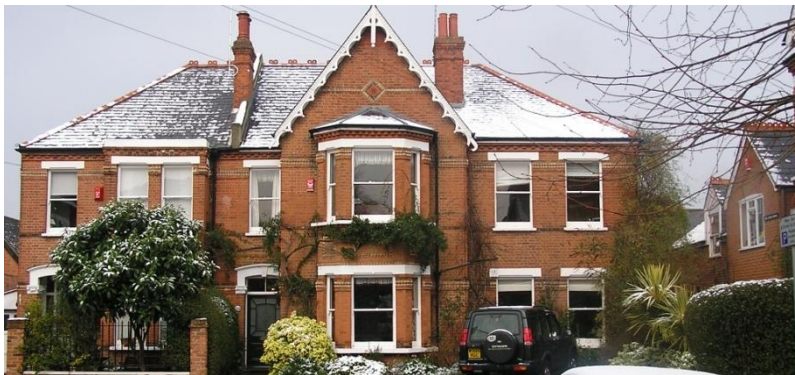
Nos. 21 and 23 Brunswick Road

3.26 Nos. 22 and 24 Brunswick Road form a new pair of houses, granted permission on 29th September 2003. The design of the street façade of the new building was closely modelled on the existing detached houses on the south side of Brunswick Road. It is of similar proportions and incorporates principal design features found in the existing houses, including square and angled bays and a steeply pitched front gable. However, the new building was set back some 8 metres from the footway to protect the existing trees.

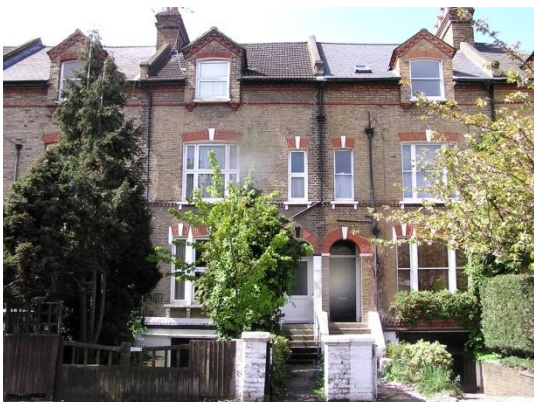
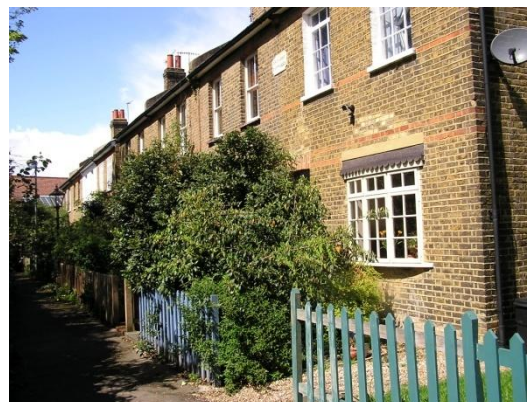
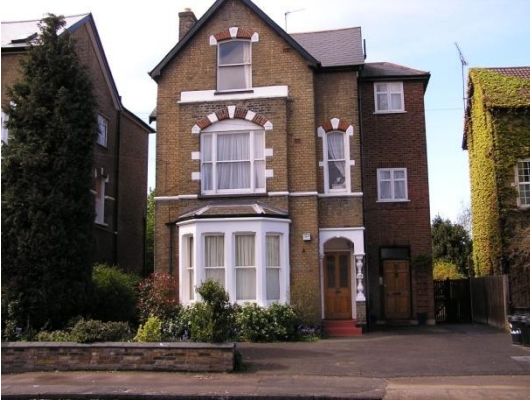
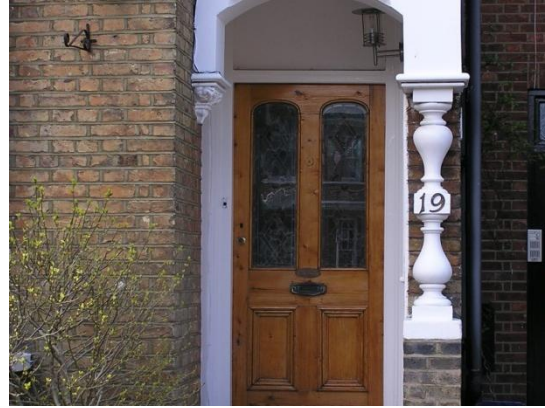
Clifton Road and Orchard Cottages: different scales, similar materials

3.33 Nos. 17-23 Clifton Road, built in 1875, are of a similar scale, but detached. Their distinguishing feature is the first floor window design, a wide segmental or cambered arch with alternating brick and stone bands, and an elaborately turned pillar supporting the porch. Nos. 17, 19 and 23 have unattractive side extensions and nos. 21 and 23 have PVCu windows, which at no. 21 are fitted throughout; those at no. 23 (which is converted to flats) have very poor proportions. The front hard-standings and lack of boundaries once again detract from the townscape.

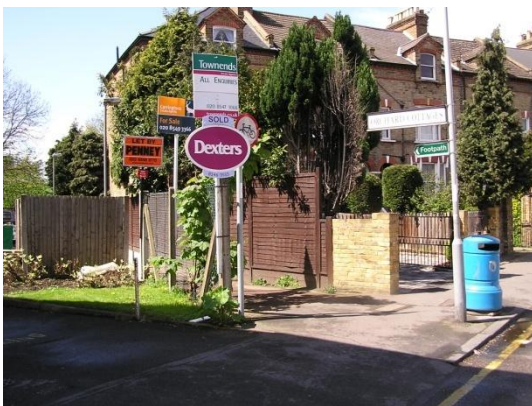
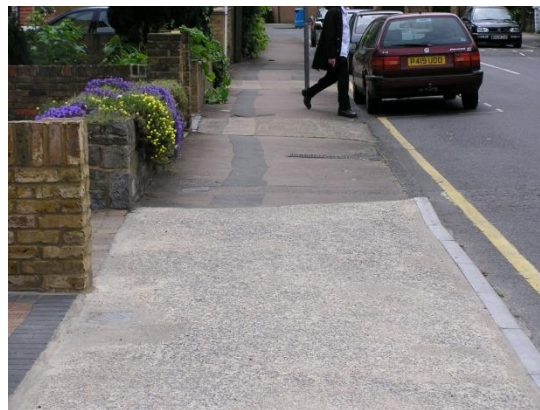
Street furniture creates a complex jumble of sign, bins, machines and notices at the entrance to Orchard Cottages. However, the historic horse trough, opposite No. 5 Clifton Road, still survives on the edge of the footway. The concrete post and plank fence newly installed on the Orchard Cottages approach path boundary is not a material of sufficient quality for a conservation area and has a dismal and utilitarian effect, as well as reducing security by completely enclosing the path and reducing overlooking in the car park.

Clifton Road: sign collection and cross-over patchwork effect

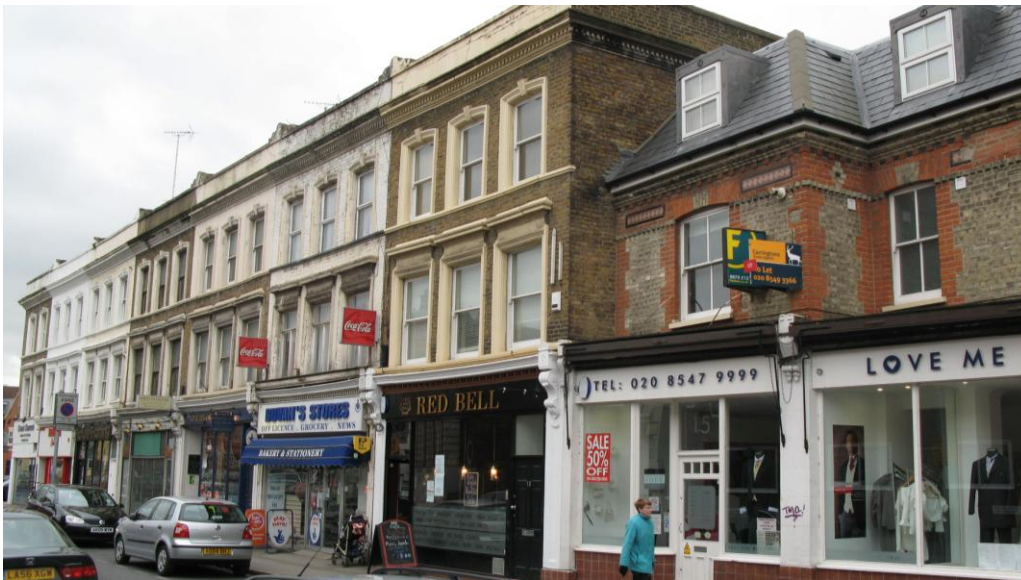
The terrace with shops at the south end of Park Road, nos.1-13 (*below*) was the earliest purpose-built shopping parade at the junction, built in the early 1870s. The shop-fronts remain free of the standard designs and fascias of national multiples, but most are either neglected, or badly altered. The terrace's distinctive character and the survival of much of its detailing is recognised in the designation of 1-13 as buildings of townscape merit, and its two upper storeys of large plain sash windows with moulded stucco survive with the majority unaltered, although nos. 1 and 11 have PVCu replacement windows whose materials and design spoil the consistency of the terrace. The shop frontages, with the exception of no.1, retain their

dentilled cornices, most retain their console brackets too, and some their pilasters and plinths. The shop fronts themselves have suffered, but the continuity of the cornices is a welcome survival and visually contains the many changes.

3.45 No 1 (Classic Cleaners) is perhaps the worst offender, and the most significant, because of its prominent corner position. All the entablature has been lost and there are no stall-risers or subdivision of the windows, and an unattractive flat sheet fascia has been applied. No.3 (The Barber's Cabin) has a poor quality deep sheet fascia. No.5 (Picture Framing) has a modern timber replica flat front in traditional style. No 7 is an ad hoc assemblage of aluminium frame and plastic panels, but retains its original entablature. No. 9 (Spirits on the Park) is a well-restored shop-front retaining the inset doors to the shop and side entrance. No 11 (Buvan's Stores) has an aluminium front and poor modern fascia with relief lettering and a fixed canopy; its two projecting bright red Coca Cola advertising signs at first floor level are totally inappropriate. No. 13 (C.Fletcher, not in current use) retains its entablature complete, although the shop-front has been changed to an undistinguished and featureless stained timber version. No.15 is currently undergoing reconstruction, but is an 1870 rebuilding of an earlier house. Only no.9 retains its early form entirely. The upper floors are characterised by lack of maintenance to window frames and paintwork.

5.19 The general condition and appearance of the terrace at 3-13 Park Road does not match its architectural quality. Enforcement of unauthorised upper window installations and site specific guidance on design, finishes and suitable joinery suppliers could encourage more owners to install good quality replacements.

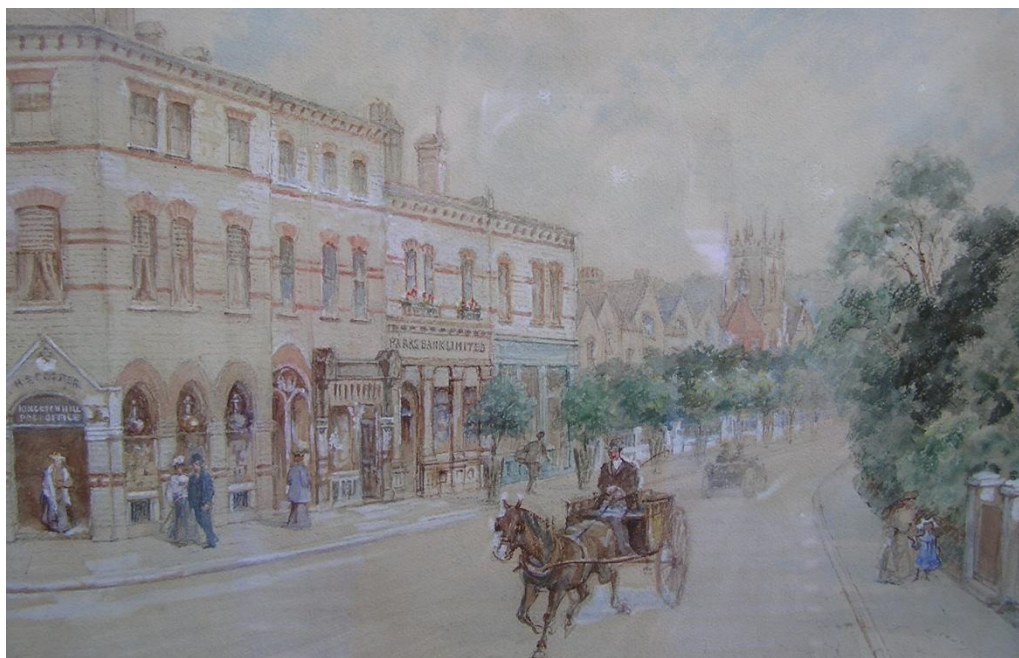
No.1-3 Kingston Hill is a 1928 design by Frederick Wheeler of Holborn and was built as a replacement for an earlier, more assertive, 3 storey building with a post office as its ground floor, seen in *Figure 7* below. Numbers 5 and 7 Kingston Hill are masked by a well-placed tree, which softens the very bland façade treatment and intrusive red brick extension; the original version of this building is seen in the painting above and dates from 1874.

Figure 7: Watercolour (undated) from Kingston Museum showing the previous buildings at 1-3 Kingston Hill

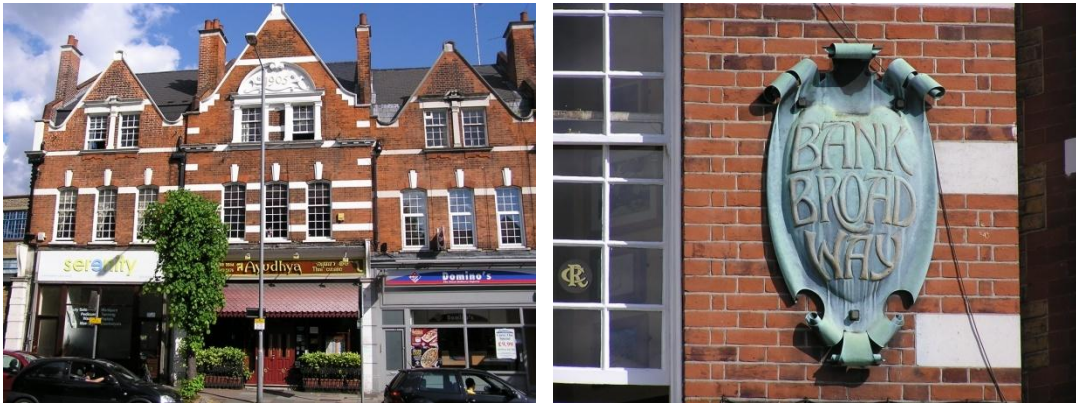
3.48 Across the road, the shopping parade Bank Broadway at nos. 4-16 Kingston Hill is much grander in scale and architectural conception than that at Park Road. It was designed by W. Wallis Baldwin of Lincoln's Inn Fields, and is dated at 1905 by the decorative inscription in the gable of no.14. The front elevation of the group is asymmetric, and the blank north end elevation and prominent gable with decorative plaque on the unit second from the end suggest strongly that it may have been intended to extend the parade into the adjoining site.

3.49 The group has an imposing presence and elegantly slender proportions, and its three storeys are topped by a slate mansard roof with tall plain stacks. White stone string courses, quoins, keystones and window surrounds in the two taller gables contrast crisply with the red brick elevations, and there are steep gables to the second storey whose looped copings add a light and playful element, echoing the cambered first floor window heads, the aprons below the second storey windows and the scrolled pediments at the first and sixth bays. The first floor windows are a distinctive feature, tall and elegant; unfortunately, no. 12 has had PVCu units installed, whose bland finish and lack of modelling in frames and glazing bars detract from the architectural quality. No. 2, now Barclays Bank, was built in 1904 (as the London & South Western Bank) by architect John Bethell of Liverpool Street. Its two storey oriel windows provide a good visual focus in longer views across the junction. The adjoining building, no.1 Manorgate Road, (outside the conservation area) makes a disappointing neighbour, with bland metal windows and unattractive fascia; it would be advisable in view of this property's important and visible position at the junction next to the much higher quality parade, to extend the conservation area boundary to include no. 1 so that there can be better control over future change.

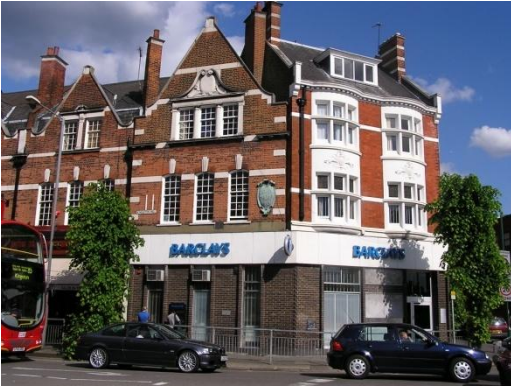
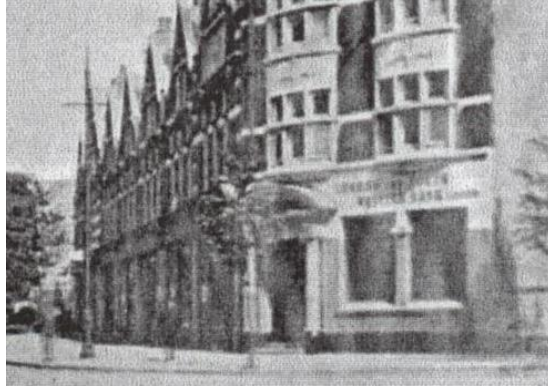
interest at street level, and the lack of modelling in the fascia deadens the frontage further, resulting in a negative effect on the conservation area.

Present and original ground floor frontage at 2 Kingston Hill (photo of 1906 from Local Studies Collection)

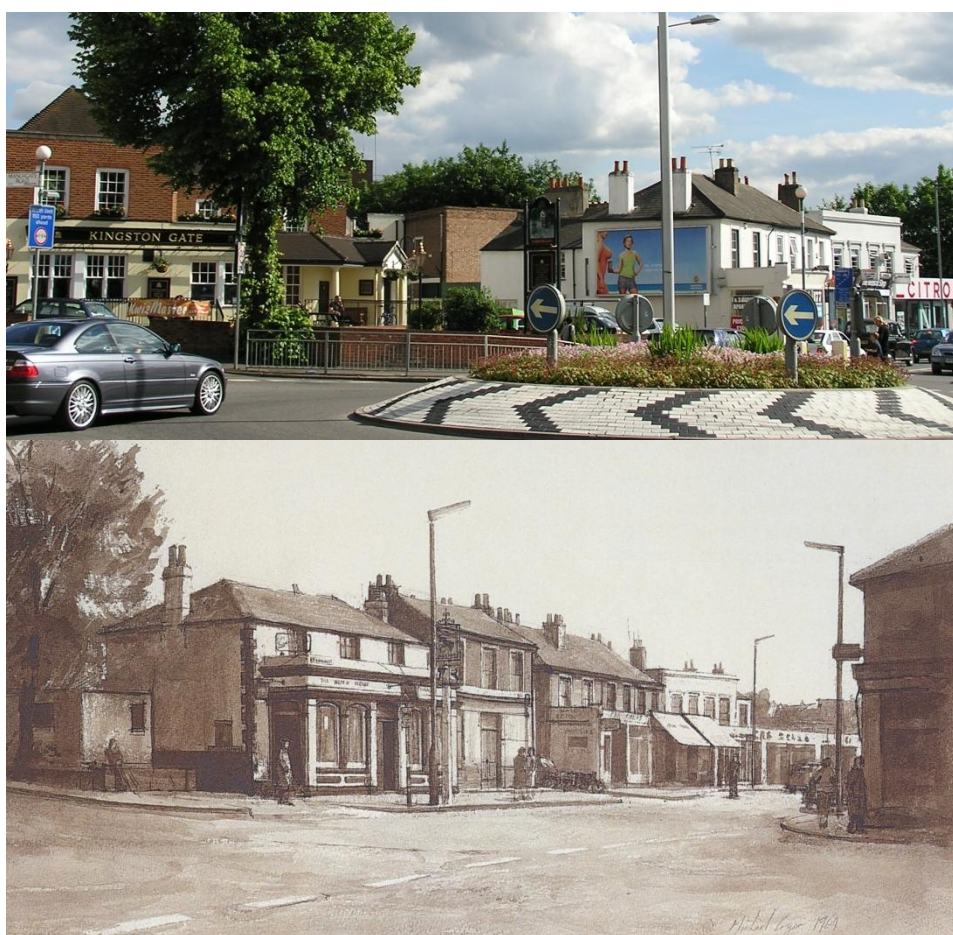
Figure 8: Top: Kingston Gate public house and Burnham Street, before demolition of 196-200 London Road in October 2006. Below: A view from the same point in 1964, in a painting by Michael Cryer from the Brill Collection, Kingston Museum. All the buildings except the furthest in the picture (194 London Road) have since been demolished.

3.42 The three properties at nos.196-200 London Road (now demolished) were until their demolition in 2006 the oldest surviving development within the existing conservation area boundary, (See *Figure 8*). They appear on the first edition OS map (*Figure 4*) with the houses in Burnham Street, a terrace on London Road's west side and two terraces in Park Road. In the mid 19th century, the only other development in the conservation area was a group of large houses - demolished to build Bank Broadway - at the foot of Kingston Hill. Nos.196 -200 were therefore rare survivors of the initial clustering of housing development adjacent to the principal route out of Kingston, before the arrival of the railway and the expansion of the junction. They provided a reminder that the commercial centre of Kingston is linked with a smaller scale residential hinterland. In 1905, the front gardens were filled in with single storey shops. The main range was unified by its steep hipped roof, and many stacks survived; these and the mono-pitch rear extensions, also with stacks, gave a well-modelled skyline. Nos. 196 and 198 retained their original shop-fronts, with slender frames and inset doors. No 200 had a modern flat shop-front, but all three retained their entablature and consoles and had modest fascias. Despite the loss of traditional sash windows to PVCu to front and rear at nos. 198 and 200, the terrace retained a good sense of its original form.

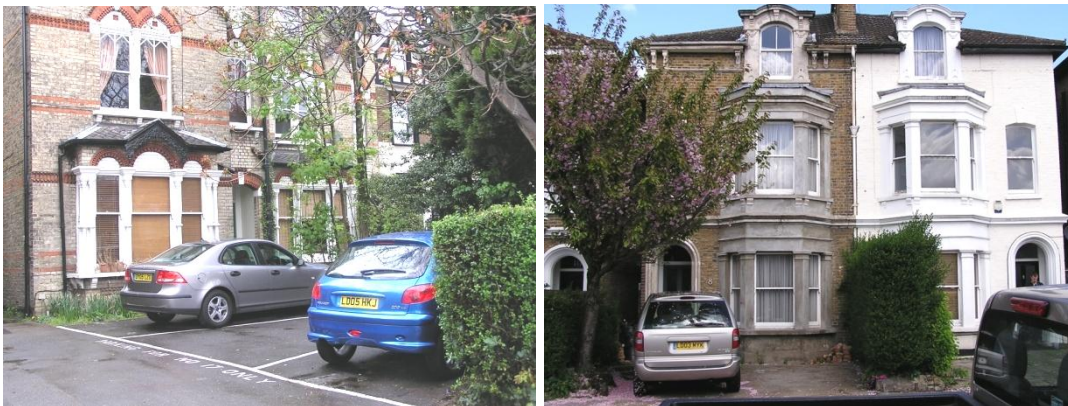
- (i) Widespread loss of enclosure from the removal of front boundaries and gardens to car parking, with poor quality hard-standings. These forecourts and the lack of boundaries detract from the high standard of design and detailing of the properties, and are detrimental to the character of the conservation area. In particular, no. 17 Kingston Hill has a particularly unattractive parking area. The boundary walls on the east side of Kingston Hill have been badly treated with intermittent replacement sections in different materials. Nos. 6, 9, 11 and 29 Brunswick Road suffer from bleak hard-standings, which bring vehicles into uncomfortable prominence against the houses because the gardens are shallow. Generally, the property boundaries have not retained their integrity; there are too many different walls and fences. Clifton Road shares with the rest of the conservation area the detrimental effect of parking in front gardens and loss of boundaries.

Damage: intrusive parking at 17 Kingston Hill; hard-standings at 2-12 Clifton Rd

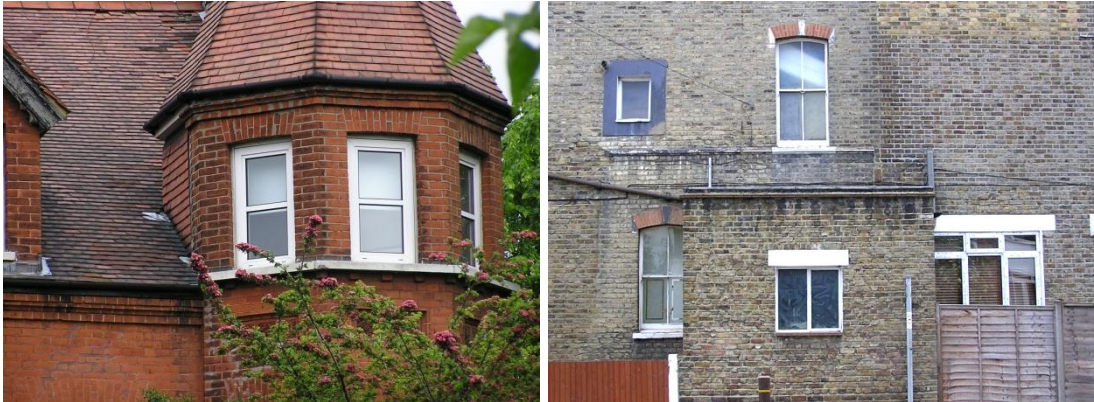
- (ii) The loss of traditional windows and doors as they are replaced with PVCu of non-traditional proportions is a limited problem so far, but one which could become more of a threat. In particular, no. 29 Kingston Hill has PVCu windows to the top floor flat (which unfortunately is the only part of the house visible above trees). No. 17A Brunswick Road has small bland PVCu windows and door and a featureless side elevation, which spoils the view towards the end of the road; no. 18A has inappropriate small-pane casements and a PVCu door, and both sit uneasily with their host buildings. In Clifton Road there are still-isolated, but ominous, examples of intrusive PVCu windows in good quality Victorian houses. No. 23 has a new rear extension, but the side windows (below) are in PVCu and have poor and inappropriate proportions and design. However, currently planning permission is only

PVCu windows at 29 Kingston Hill and window pick-and-mix at 23 Clifton Road

- the application of existing policy BE3 to cover replacement with non-traditional materials and designs of doors and windows in buildings without permitted development rights, since these are material changes which affect the character or appearance of the area;

- amplifying policy BE3 to make it more specific with regard to alterations, and preparing supplementary design guidance for the whole conservation area to complement the policy, particularly specifying in what circumstances replacement joinery can be in non-traditional materials where PD rights do not exist;
- applying further control through Article 4(2) directions, accompanied by site-specific design guidance;
- ensuring that unauthorised work to traditional joinery is the subject of a retrospective planning application, and taking enforcement action if necessary;
- encouraging co-ordinated enhancement schemes for shop-fronts, in line with the council's existing supplementary planning guidance, supplemented by site-specific guidance.

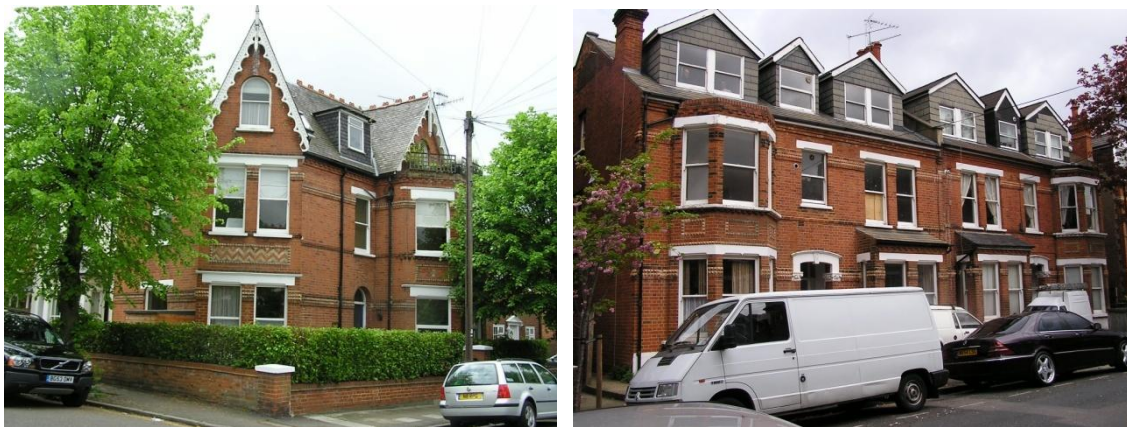
- iii) Pressure for loft conversions resulting in inappropriately large dormers. On the north side of Brunswick Road, there have been ugly and apparently contagious outbreaks of large dormers; nos. 9 and 11 are particularly unpleasant, with three separate dormers crammed together on each property; no.15 has a single continuous dormer across the whole roof. The rear view from Park Road is equally dire, with the row of long flat-roofed dormers completely distorting the rear profiles of the houses.

The corner gable in Brunswick Road is charming, but the dormer additions down the road are disastrous

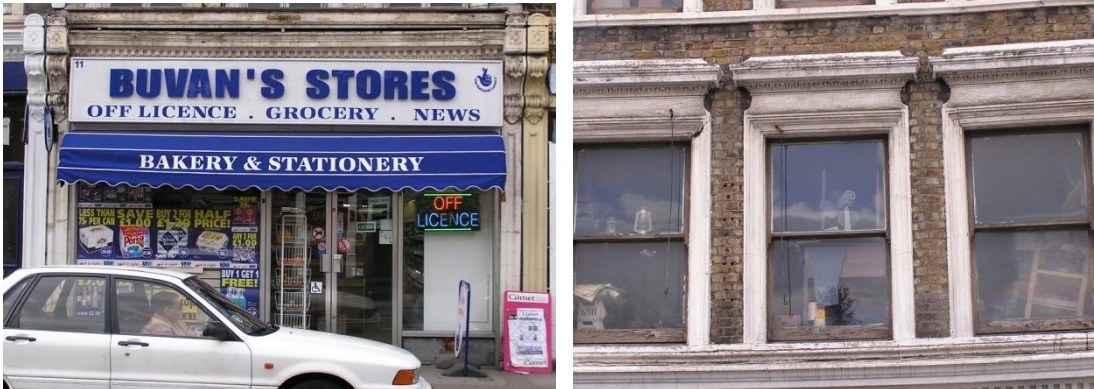
Park Road suffers from inappropriate shop-fronts, and upper floors in poor condition

- (v) The under-use of upper floors and lack of maintenance in more marginal shops is evident at Park Road, which may be suffering from lack of convenient parking and lack of demand. Nos.1-13 Park Road are, with few exceptions, in poor condition (the condition of the fabric of no.7 is a particular cause for concern, with its upper floors used as ancillary storage).

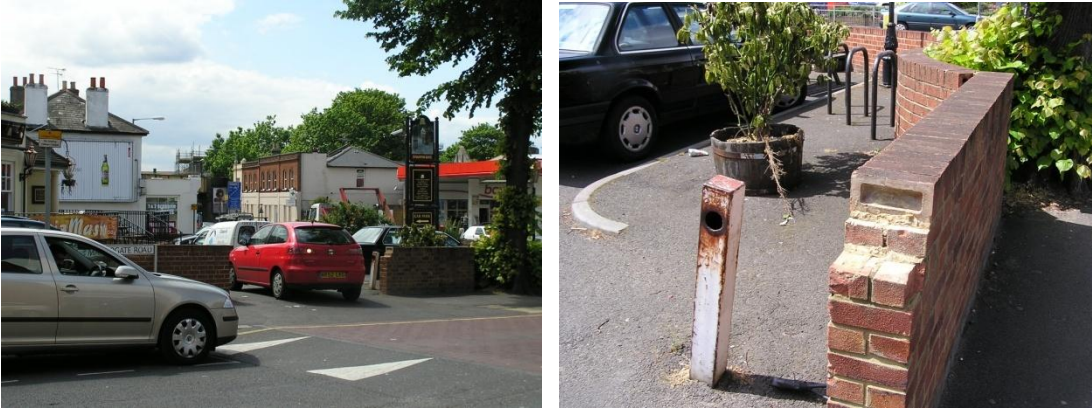
- (vi) Poor quality development, intrusive forecourts, low quality street furniture and footway surfaces in the public realm. The townscape in Brunswick Road has suffered some loss of quality at the eastern end, where both nos. 17 and 18, on opposing sides of the road, have had large additions built in their former rear gardens, forming poorly designed new units with sizeable parking areas. Through gaps between the houses on the north side of Brunswick Road, the commercial buildings at no. 16 Park Road make a poor prospect. From Park Road, the surgery building no.1 makes an unattractive 'gateway' to the conservation area, with low-quality fencing, no planting, and a selection of functional street furniture. In Clifton Road, two developments outside the conservation area detract from its setting; - the car park on the south side of Clifton Road, and Aldous Court. The tarmac forecourt to the Kingston Gate public house has a negative effect on views. Outside the conservation area, the Total petrol filling station on the other side of the road provides an inappropriate setting for this group, as does the Citroen frontage at nos. 192-194 London Road.

The Kingston Gate forecourt is unsightly, both in scale and in detail

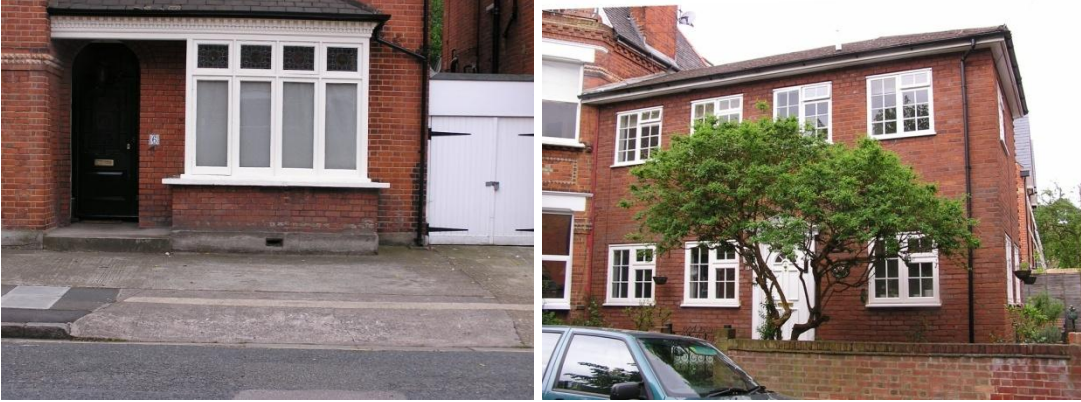
damage has already been done to roofs under permitted development, although some has been done with planning consent. Pressure for off-street parking has led to the creation of hard-standings in small front gardens; this seriously affects the streetscape, as effective screening is not possible.

Hard-standings and unsympathetic extensions have affected the townscape quality

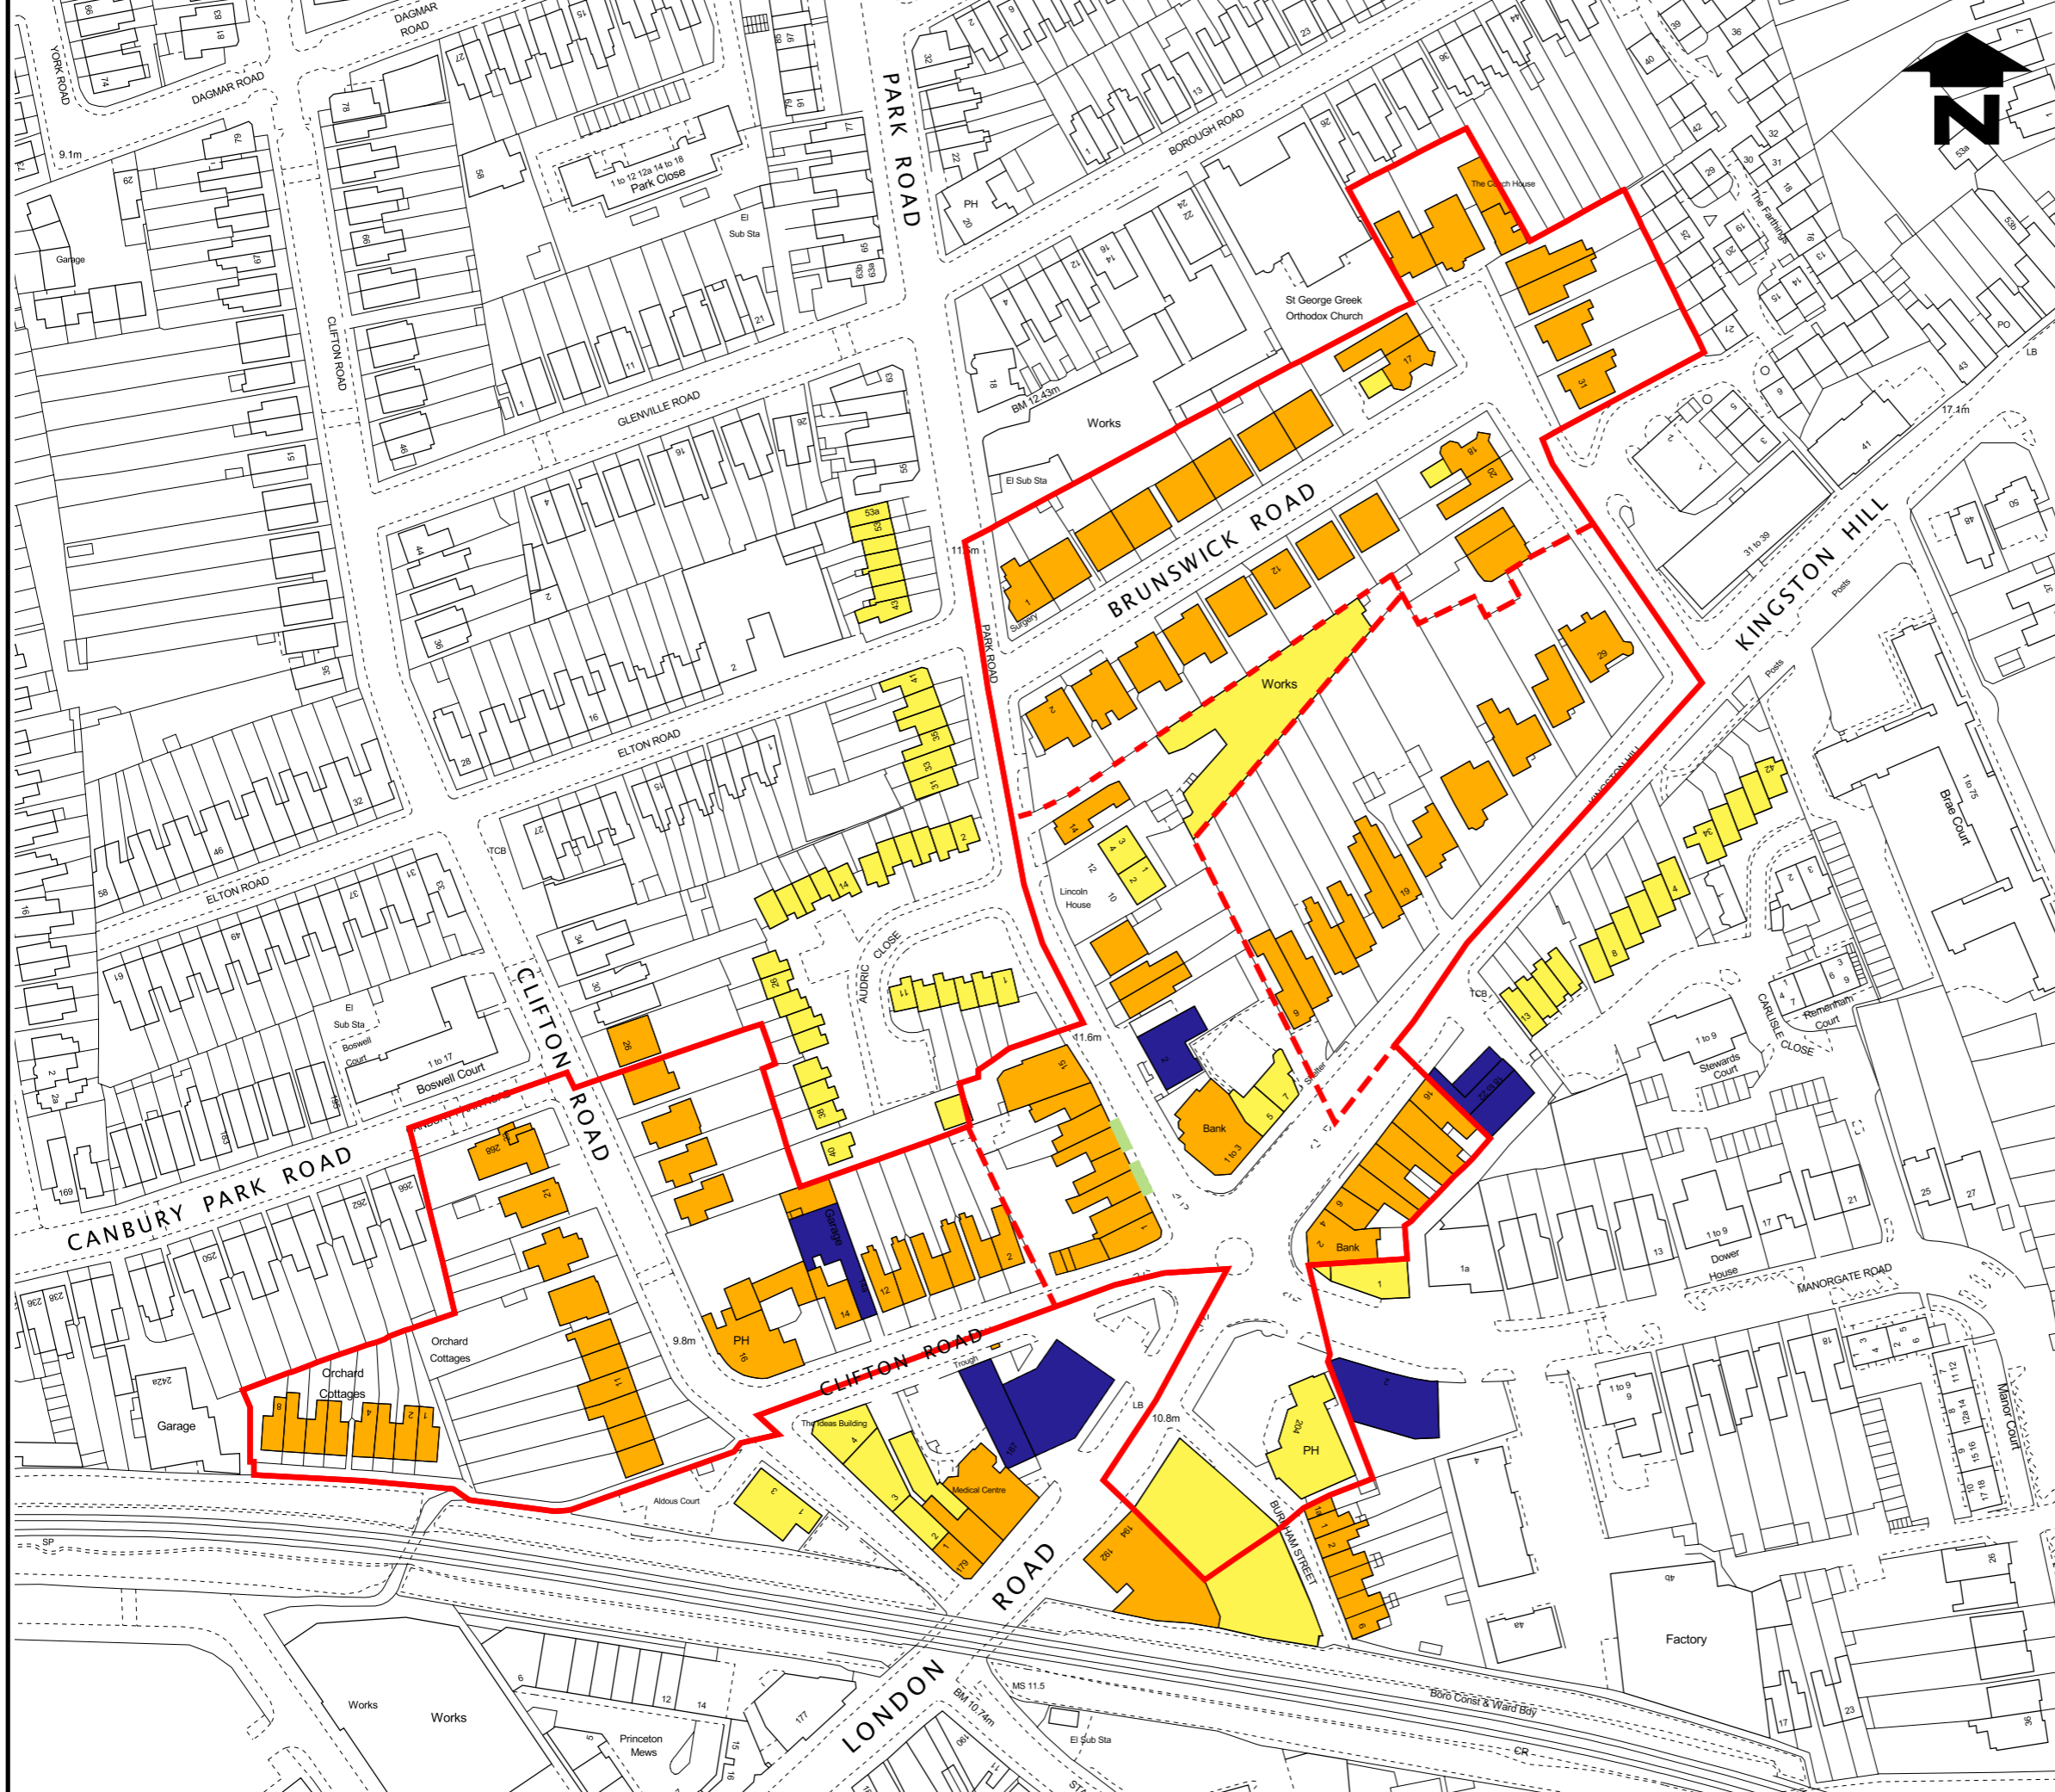
PLAN 6a

BUILDING CHARACTER ANALYSIS

Date: MARCH 2008	Ref: REVIEW
Scale: 1/1,500	Dwg No: 08/006/B
