Royal Borough of Kingston upon Thames
Character Appraisal and
Management Strategy Programme

Park Road Conservation Area

July 2008

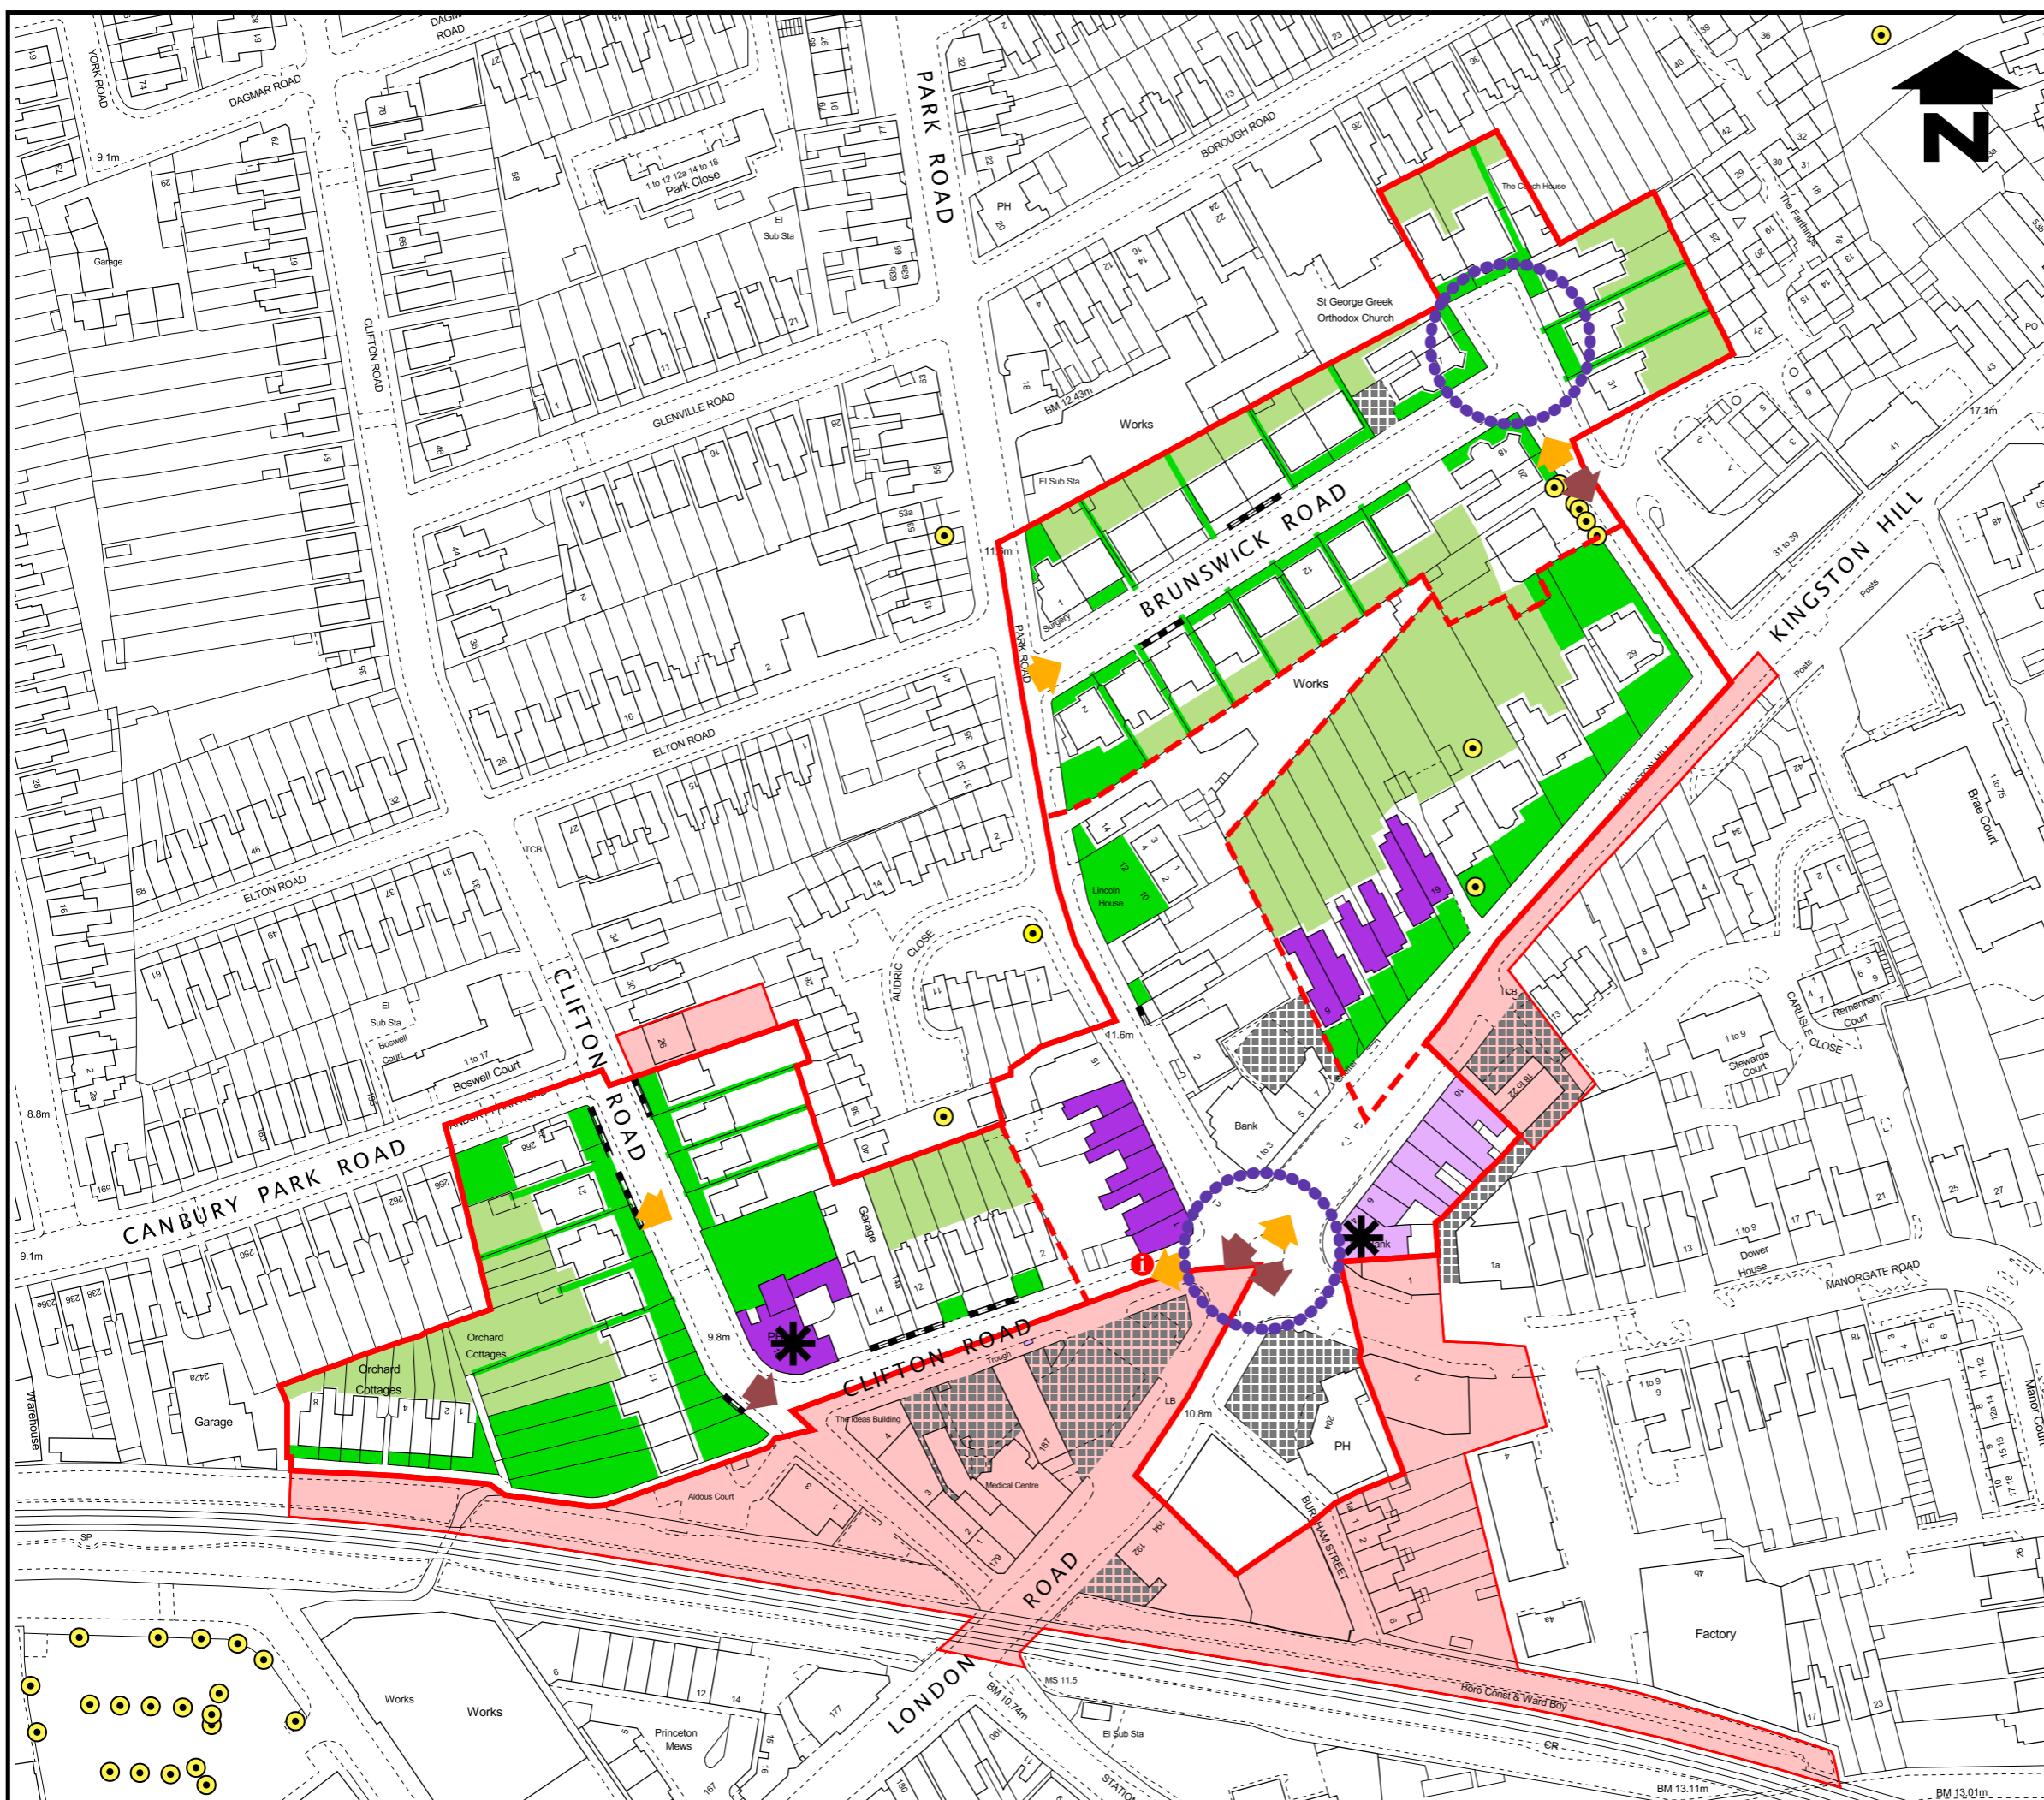
PLAN 7a

TOWNSCAPE ANALYSIS

Date: MARCH 2008	Ref: REVIEW
Scale: 1/1,500	Dwg No: 08/007/B
